Technical Article: Corrosion

This article outlines some of the
causes and cures of metal destruction
in the marine environment.

CORROSION

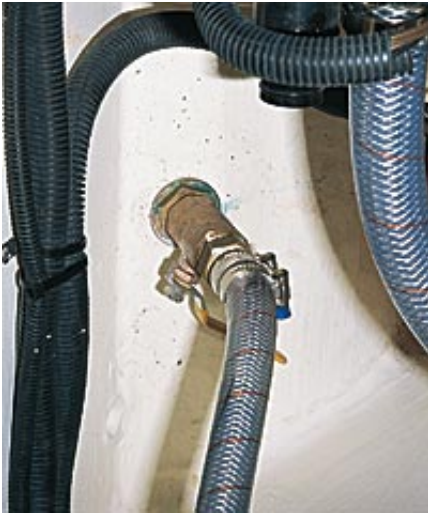
This new bronze skin-fitting (above) is beginning to oxidise. Note the characteristic green colour. The skin-fitting should have been mounted on a block to provide additional strength to the local area of the hull.

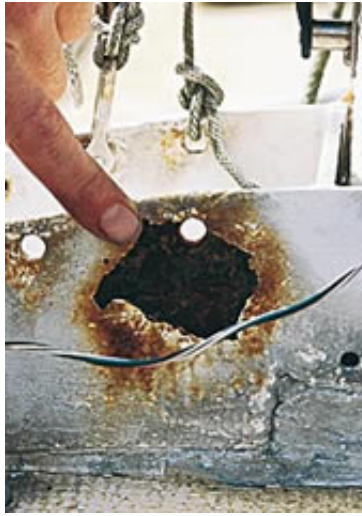
A large rust patch was started by water getting under the protective paint work at the edge of the hole and has resulted in substantial damage.

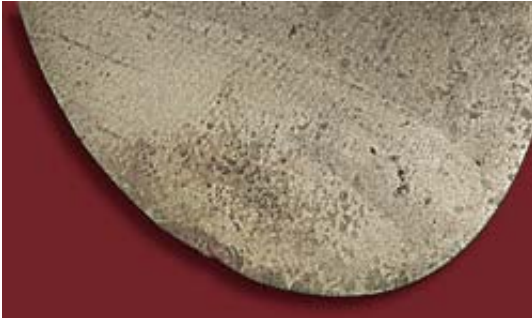
Left: The small red patch at the tip of this propeller is de-zincification. The large pitted area close to the blade tip is caused by cavitation.

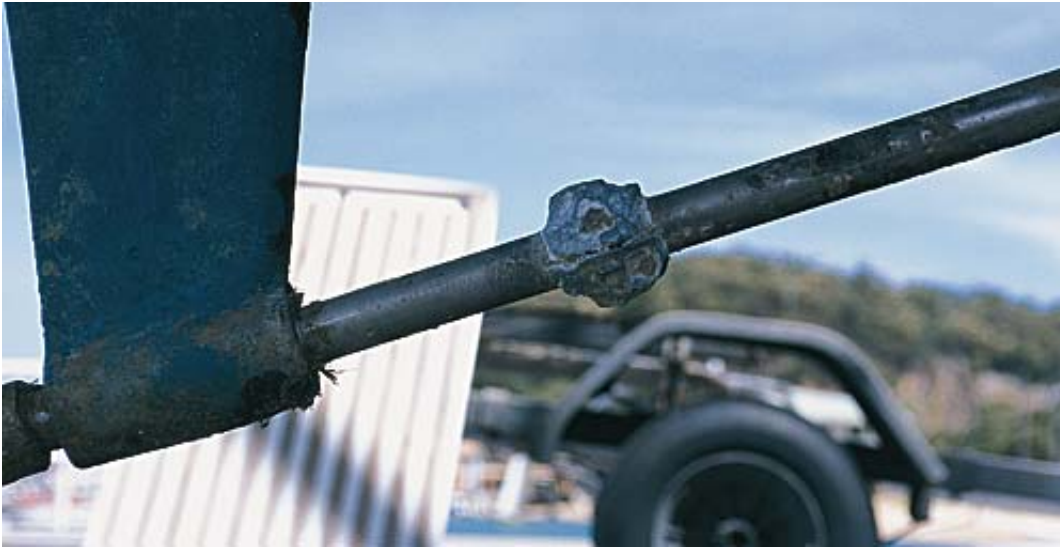
Below: This zinc block has been seriously eaten away. It should be replaced immediately

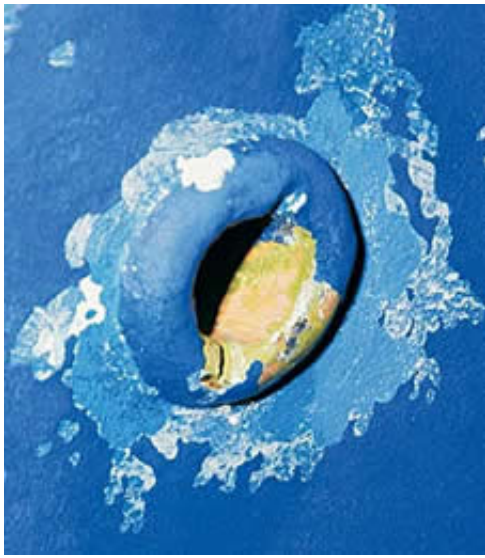
This skin-fitting is suffering from well-advanced dezincification and should be replaced immediately. The owner did not replace it when advised and it nearly caused the sinking of the vessel.

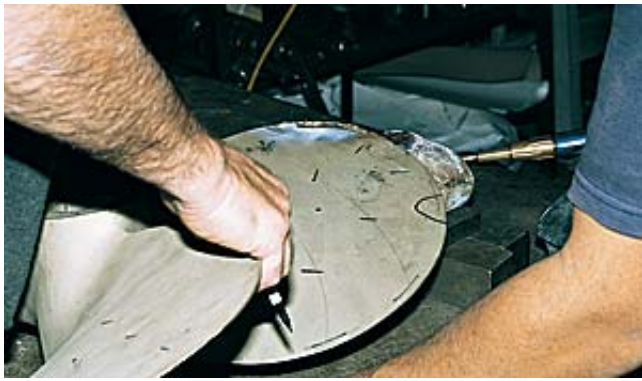
Damage or corrosion to propeller blades can sometimes be repaired, but it requires the skill of an expert. Do not try to do this yourself
